2019 Annual Report

Nestlé Waters North America Inc.

Chaffee County 1041 Permit

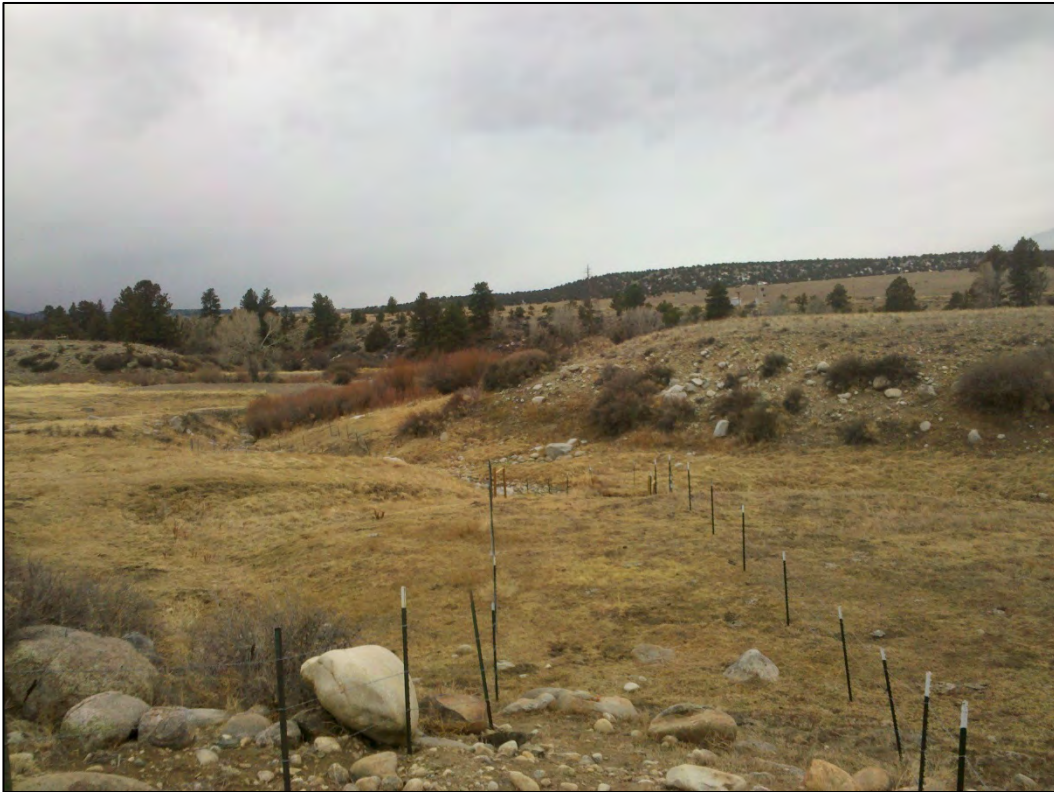
Figure 2. Alleyway installed in 2011 on BHS property to allow cattle water access when grazing the upland area

erosion and sedimentation. Construction of an alleyway water-access point for upland livestock containment has been installed. See Figure 2 for the installed water access alleyway. Its use in 2012-2014 was a success.

No repair work or other site work was conducted in 2017. Repairs to fencing and exclusion structures around springs are recommended before livestock are reintroduced to the units. It appears that excessive runoff in 2017 resulted in accumulation of debris along structures, pushing them over and rendering them ineffective. No maintenance was scheduled or performed in 2018 or 2019.

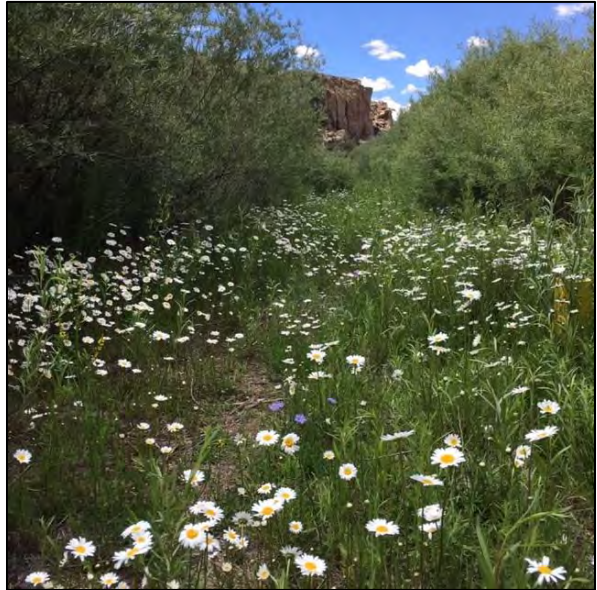
Photo 1. Oxeye daisy infestation 2019

Invasive plant species identified at the site in 2018 and again in 2019 include mullein (*Verbascum thapsus*), oxeye daisy (*Leucanthemum vulgare*), and stinging nettle (*Urtica dioica*). Although considered a native species, stinging nettle is given the distinction of an invasive native species and is commonly found to aggressively colonize disturbed areas. The leaves of nettles are covered with tiny hairs that contain formic acid and are a skin irritant in humans. The plant has been managed on the property in the past due to significant patches of it which prohibit access to photo monitoring points. It is strongly recommended that this species be added to the list of plants for future maintenance and management.

2019 site visits concluded that mullein and oxeye daisy continue to be an invasive problem and will require active management to reduce their spread. Due to transitions in NRNA site management and vegetation management, willows and other native plant species have grown unimpeded over the last few years. Discussions in fall of 2018 with NRNA concluded that future management would shift back toward maintenance of natural revegetation along pathways and around water features. In 2019, active and on-going cutting of willows has been implemented as a management strategy to prevent the dense vegetation from inhibiting access to walking paths and ponds.

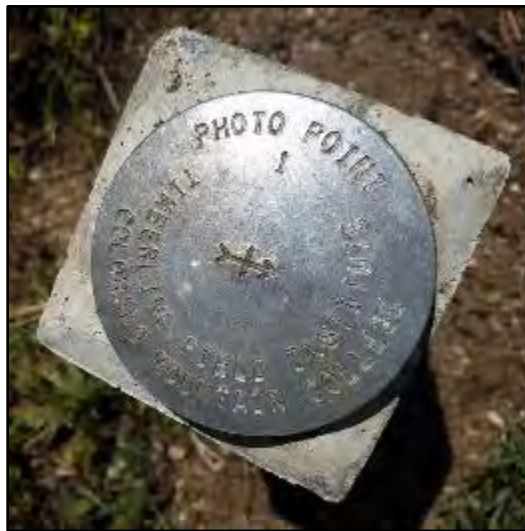
Photo 2. Photo point monument installed in 2016

- Repaired lower bridge
- Cleared debris along top of Arkansas River bank throughout Site
- Continued to clear stream-flow obstructions and site-wide debris
- Installed new photo point monuments
